Ferroelectric Cathode

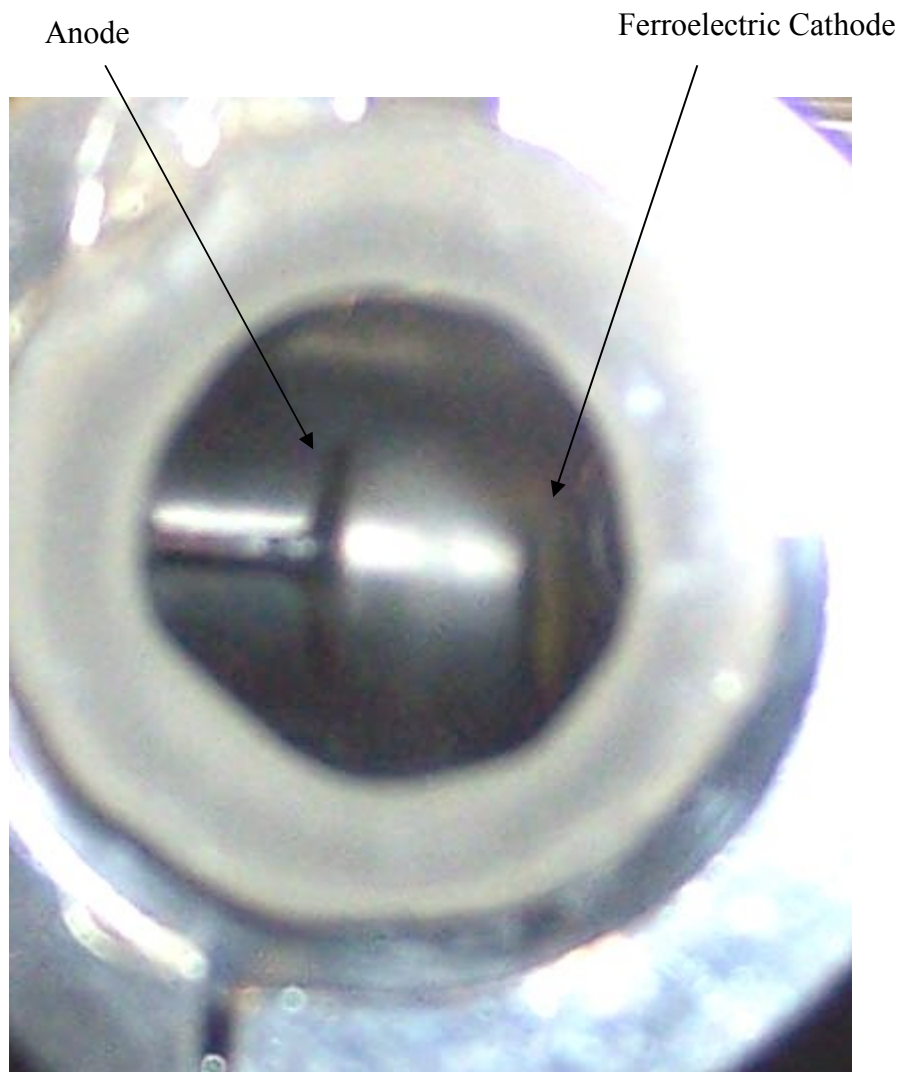
The ferroelectric cathode is activated by the indicated switch allowing the three capacitors ( initially charged to ~ 1KV) to apply a positive pulse to the cathode.

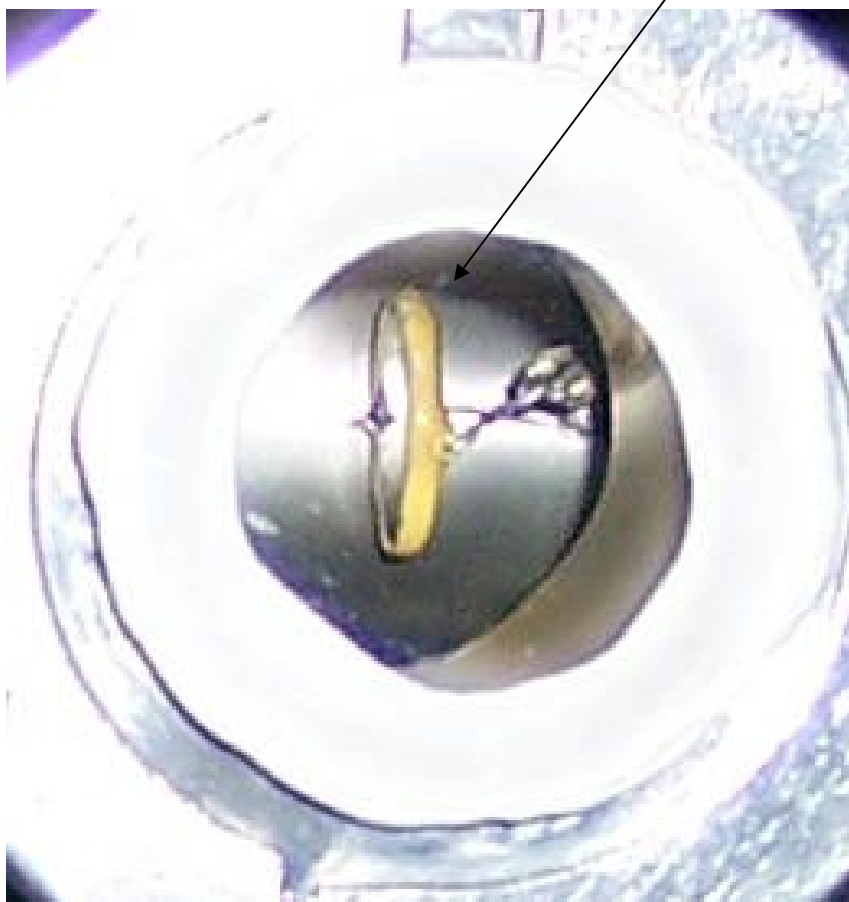
Photo 2 Observation Window From Previous Note

The exact cathode anode spacing has not been determined yet ( guess about 3/4 “); I don’t want to open the vacuum chamber until I am finished. At the moment I can get down to 5E-6 Torr in about 4 hours; however when the system is exposed it takes longer depending on the atmospheric conditions.

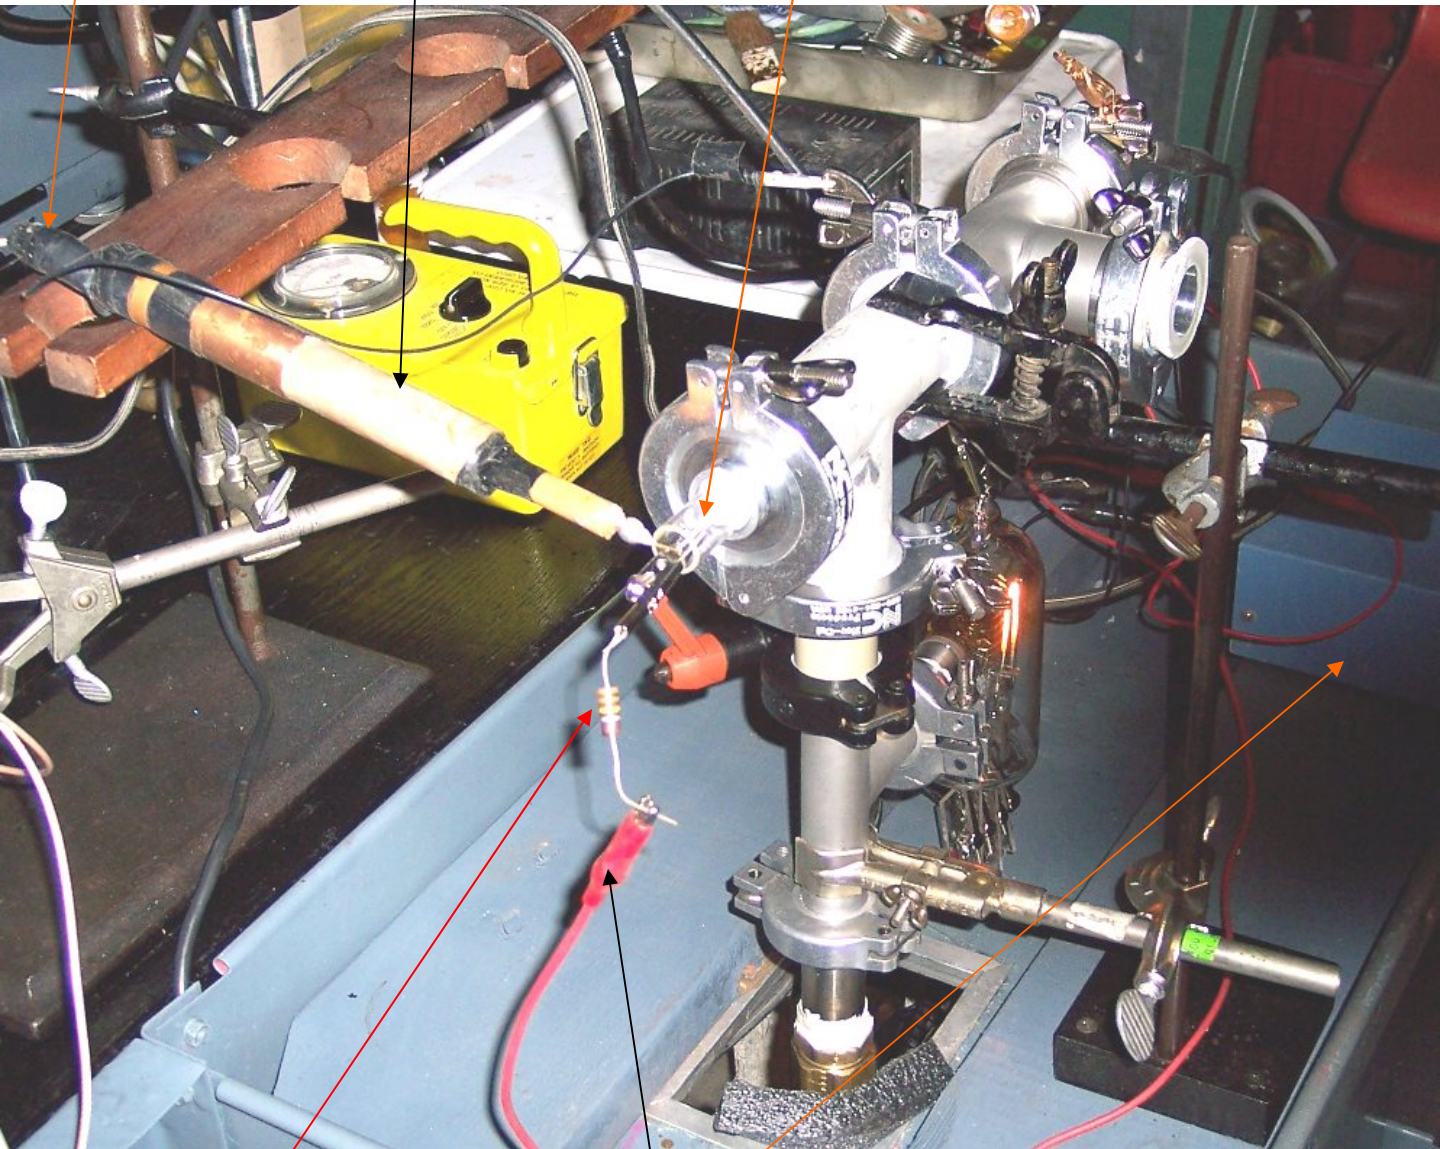
Photo 4 Anode Electrical Connections ( Resistive Load Only)

To DSO

HV Probe

Anode Input

330K resistive load

+ 1KV Source

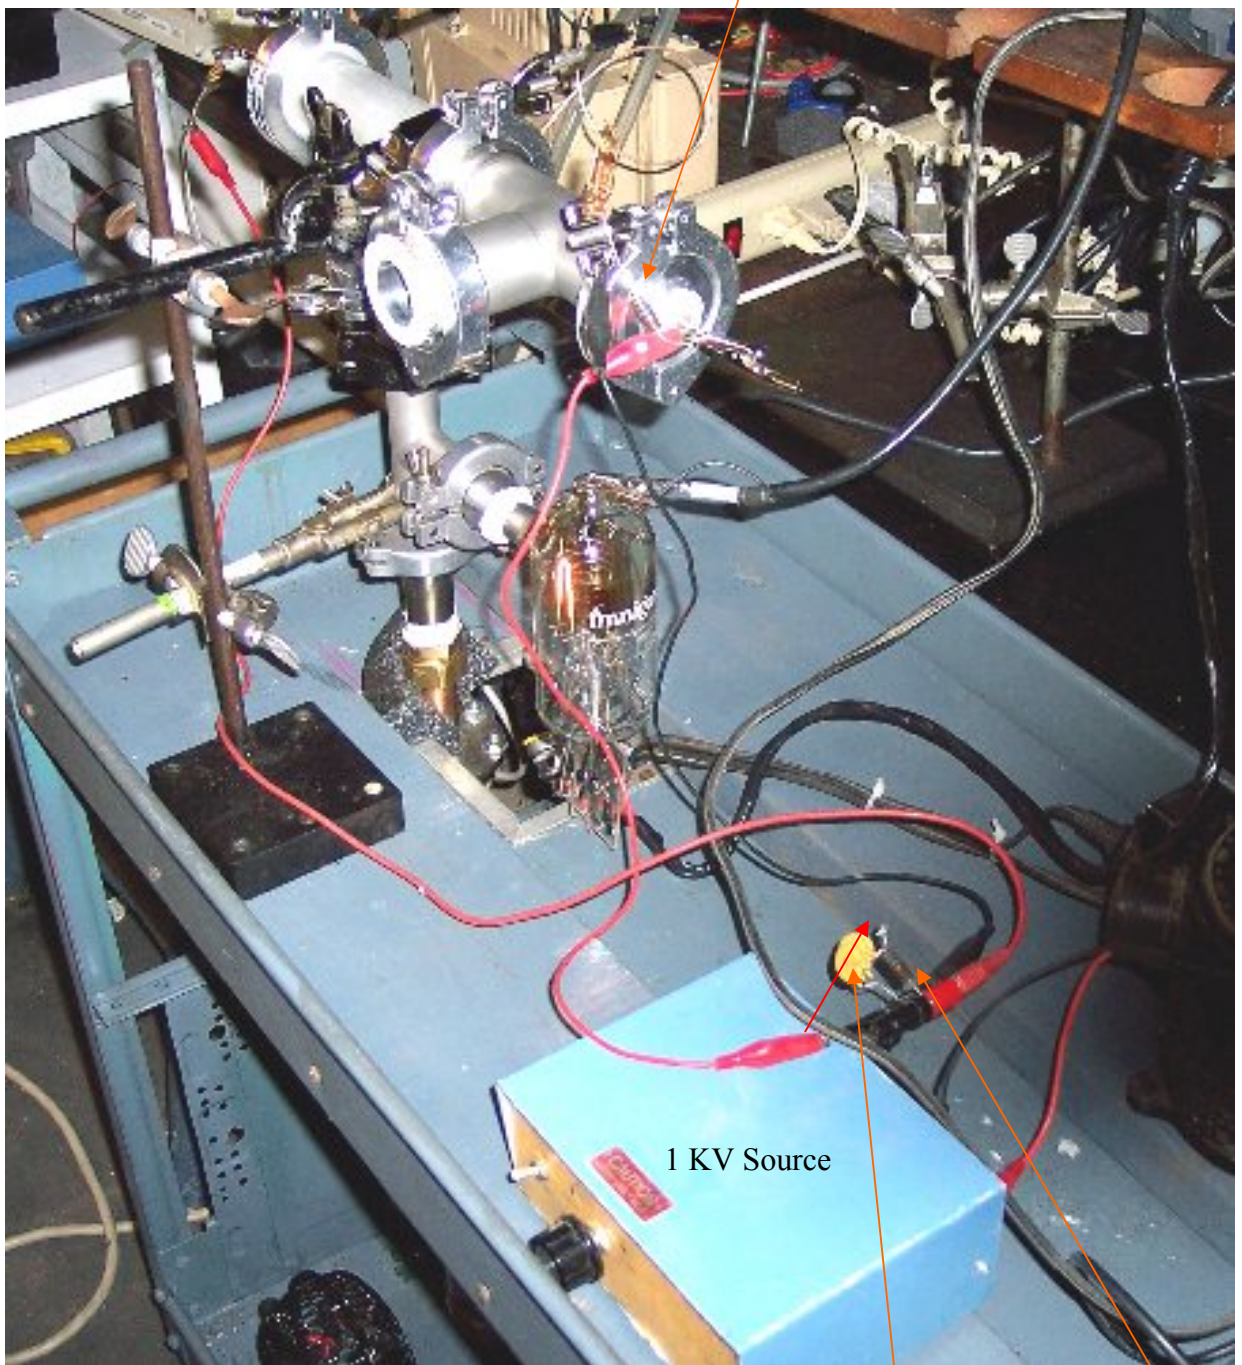
Photo 5 Cathode Electrical Connections

15 M cathode shunt to GND

Red alligator clip is touched to the charged capacitors ( ie the SW)

Three 2.7nF ceramic capacitors charged via 15 M

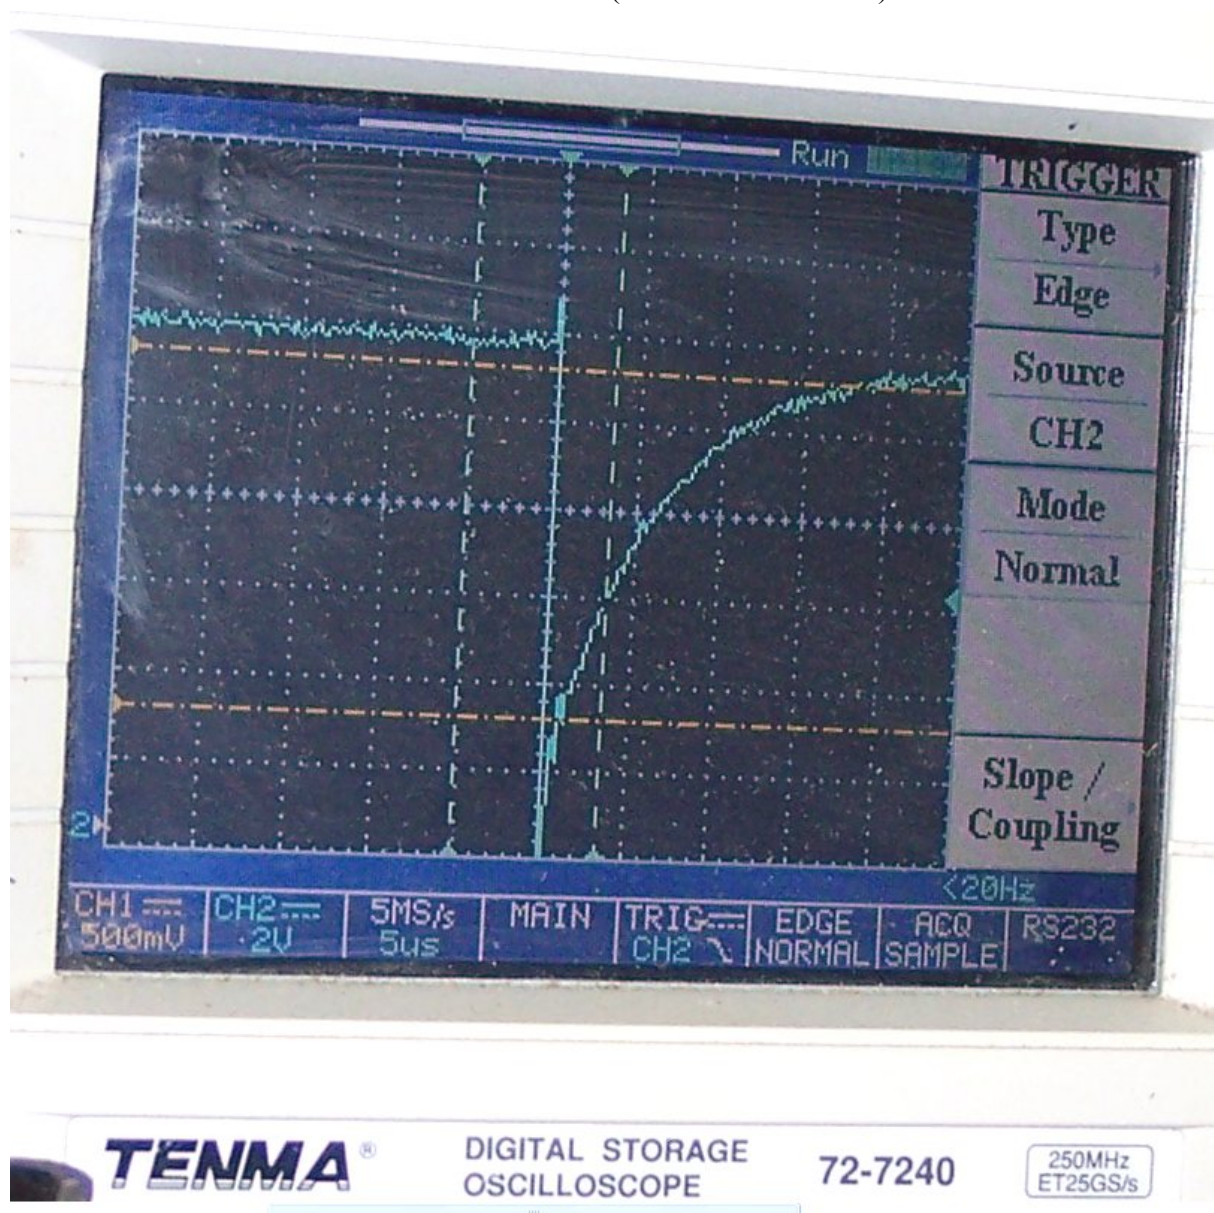
Photo 9 DSO Waveform

X 100 ( Vertical set to X 10)

I have given a rough description of how the ceramic emitting surface was prepared ( nothing even near as good as what has been described in the literature); for this reason I was not expecting great; all I was interested in was to see if the effect could be observed. I was amazed that I got the above!!! However the above pulse waveform initially did not occur every time the red alligator clip touched the three charged capacitors.

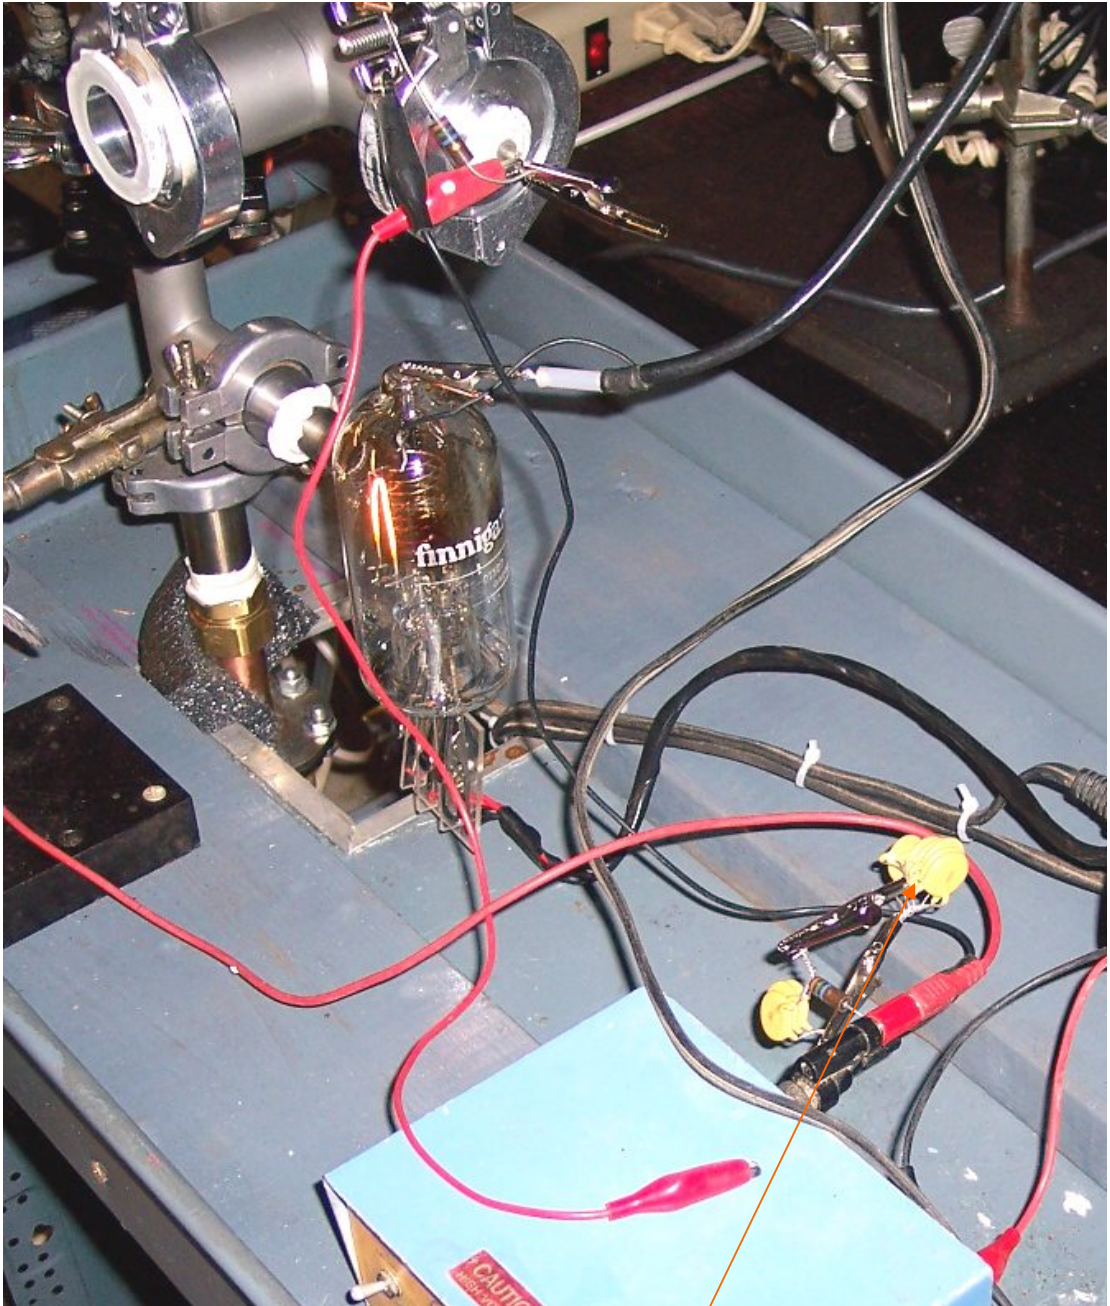
Photo 11 Added Six More Capacitors

I decided to add more capacitors in parallel in order to provide a greater positive pulse; the result was significant and very successful as indicated in the next several pages.

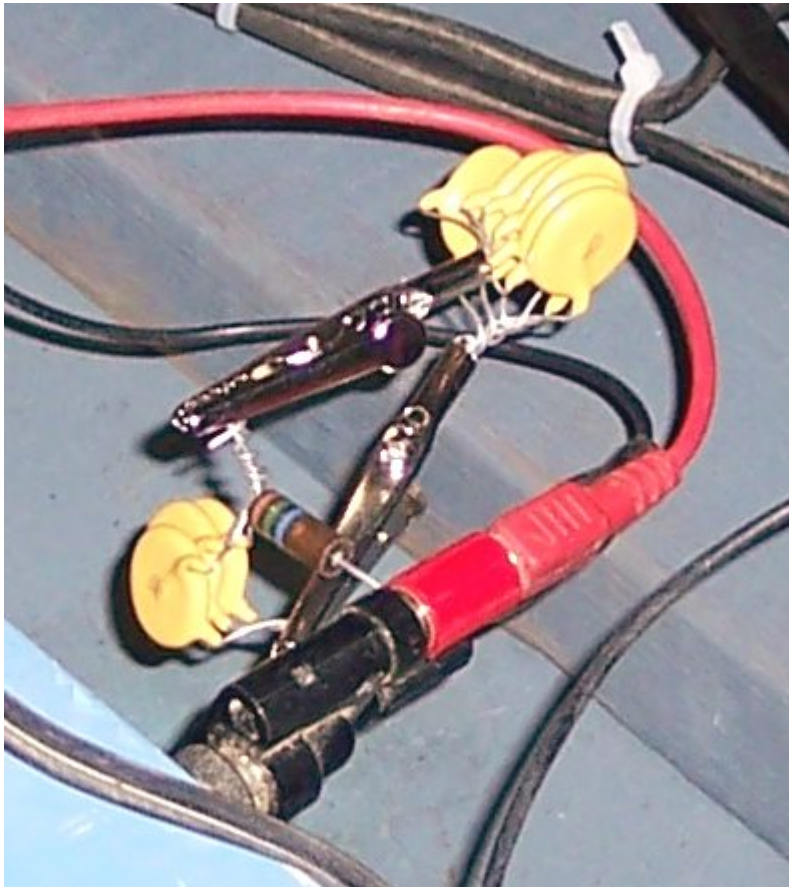
Photo 13 Note the Difference from 9 !!

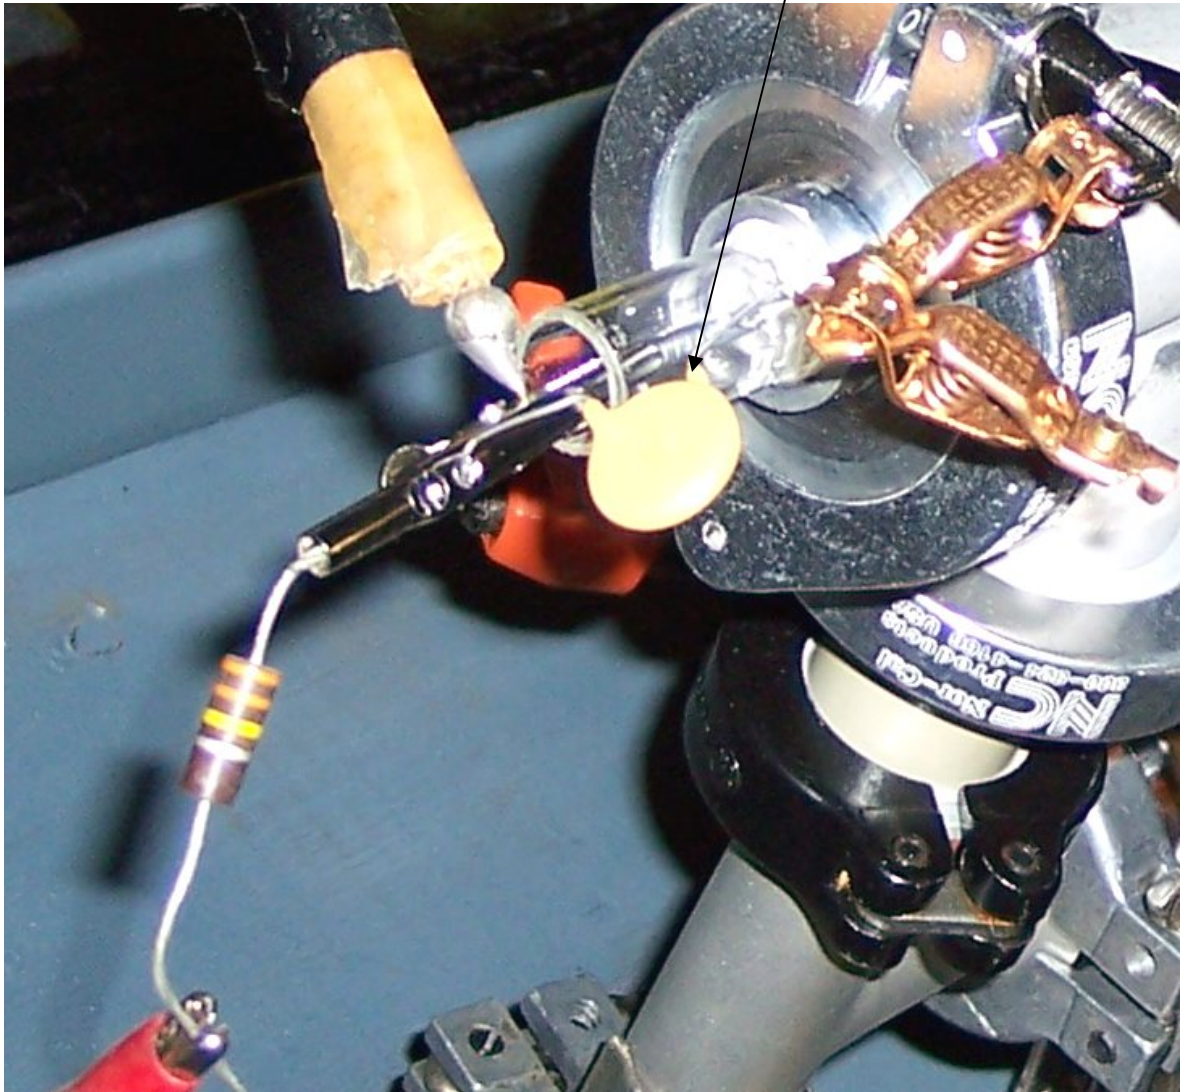
Photo 14 Shunt ( to GND) the Anode With a 2.7NF Capacitor

The next day a 10 ohm resistor was connected with the anode loading capacitor to GND; used for current viewing; got 150 volt pulse across the resistor. I know that in the literature 100's of AMPS were reported but 15 AMPS is nothing to sneeze at!! I am shocked ( no pun intended) considering a not so great emission surface was prepared using a X10 Stereo microscope.
